Concrete, Construction, or Salt— Which Causes Scaling?

Part 2: Importance of finishing practices

BY DIPAYAN JANA

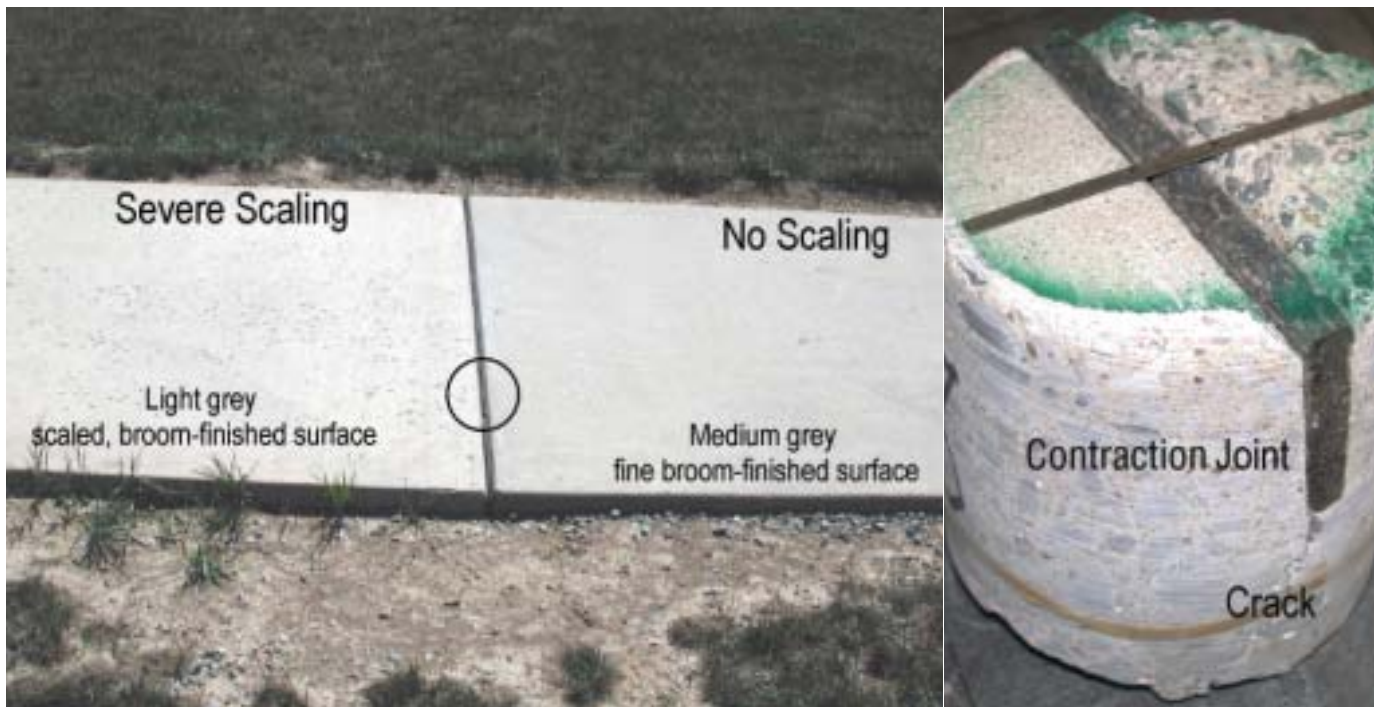
Fig. 2: Case study II (Scaling due to finishing in the presence of excess water at the surface)—Concrete core from a contraction joint showing adjacent sound and scaled surfaces

Figure 2 shows a core taken from a contraction joint in a sidewalk having adjacent sound and scaled panels.

Both panels were made using the same concrete and were sealed after finishing with a cure-seal compound. Cores taken from both panels have good air-void systems and similar chloride contents (Table 2); but the top 1/2 to 3/4 in. (13 to 19 mm) in the scaled panel was found to have soft, porous, fragile paste compared to the interior of the slab or to the concrete in the sound panel.

The soft paste of the scaled surface was due to a higher water-cementitious materials ratio (*w/cm*) in the surface paste relative to that in the rest of the slab or in

the sound panel. As a result, there were fewer residual portland cement particles at the panel surface and a greater depth of carbonation compared with the sound panel (Table 1). Soft, high *w/cm* paste at the scaled surface typically occurs when finishing is performed in the presence of excess water at the surface (from bleed water and/or from water added during finishing). This soft paste not only reduces the abrasion resistance of the surface, but also increases its vulnerability to scaling due to cyclic freezing at critically saturated

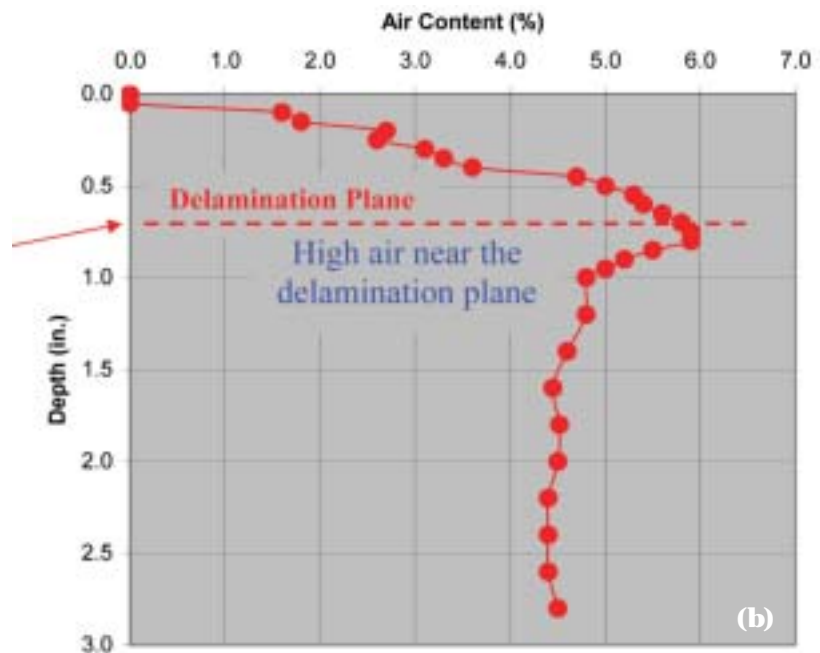
Fig. 3: Case study III (Delamination due to prolonged finishing and entrapment of bleed water and air beneath the finished surface)—(a) cross section of a concrete core, and (b) air profile showing the dense, air-free, near-surface mortar, the plane of delamination, and the air-entrained concrete in the slab. Note: 1 in. = 25.4 mm

troweled indoor slabs. Figure 3 shows an example of finishing-induced loss of air at the surface of a warehouse slab where delamination developed due to finishing prior to the cessation of bleeding, accumulation of bleed water and air underneath the dense machine-troweled surface, and development of a “plane” of delamination. Air entrainment was included due to the anticipated exposure of the concrete to freezing during construction, but the slab was subsequently delaminated due to the machine troweling of the air-entrained slab.
